**Report on Conditions 16 July 2008 at the Buck Island Lake
Area on the Rubicon 4x4 Trail, An El Dorado County Road
in the Eldorado National Forest, California
by Monte Hendricks**

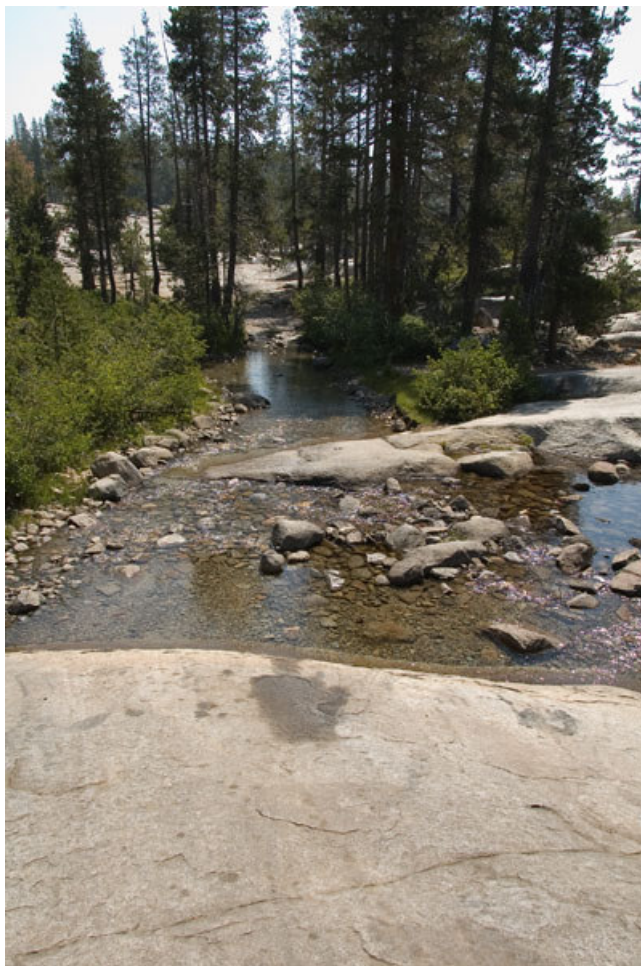
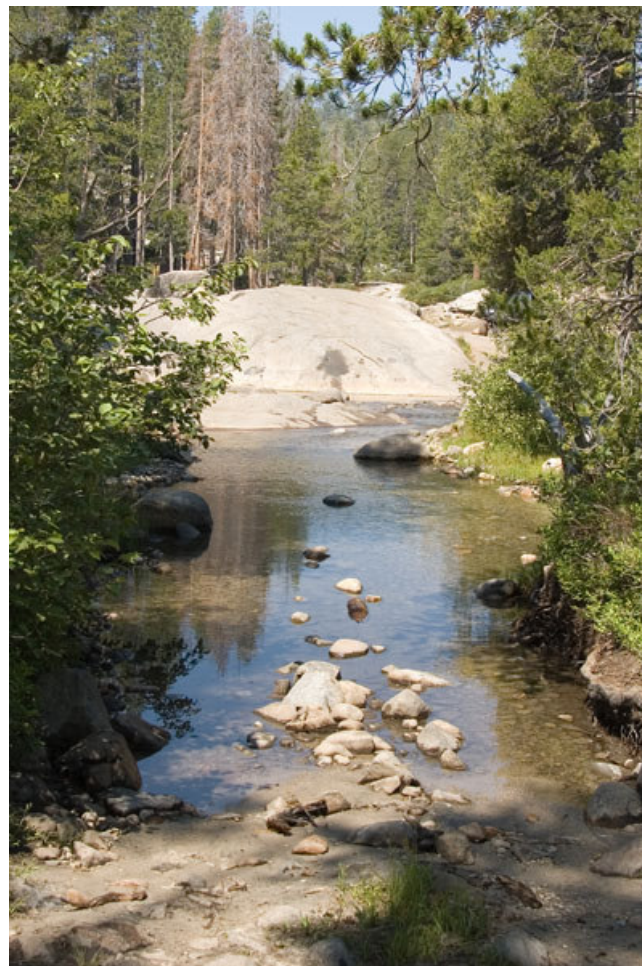
The photos above are of the main crossing of the Little Rubicon below the dam at Buck Island Lake. The left photo is looking southeast toward Buck Island Lake and the right photo is looking back in the opposite direction. Please note the oil spill that ran down the granite and into the stream. Please note that the cobble streambed looks fairly clean here. The streambed looks different downstream from here as following photos will show.

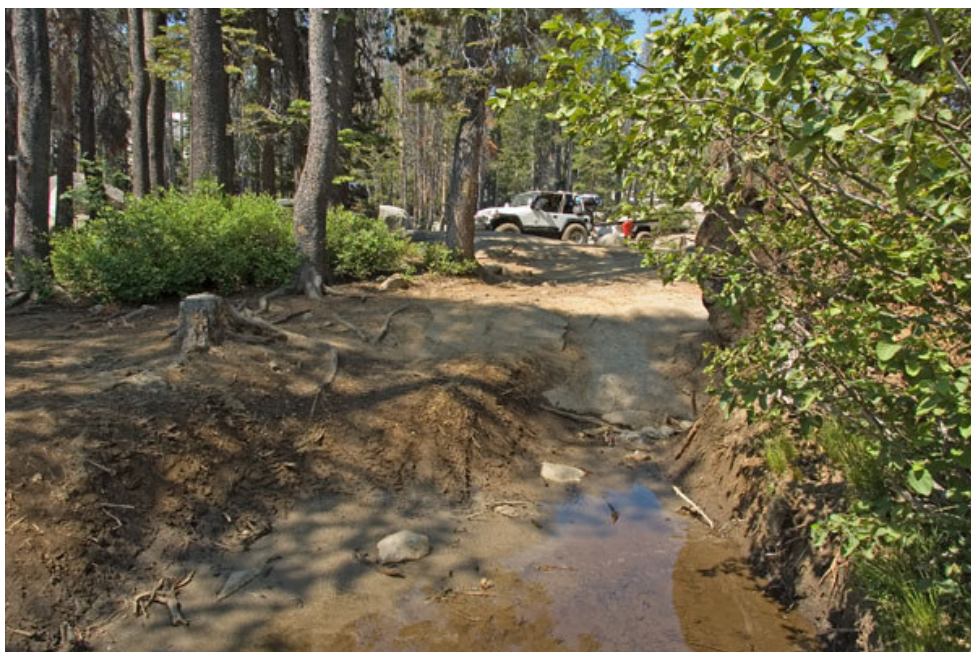
Vehicle use is so heavy on the Rubicon Trail that this is the approach to an alternate crossing just downstream from the main crossing.

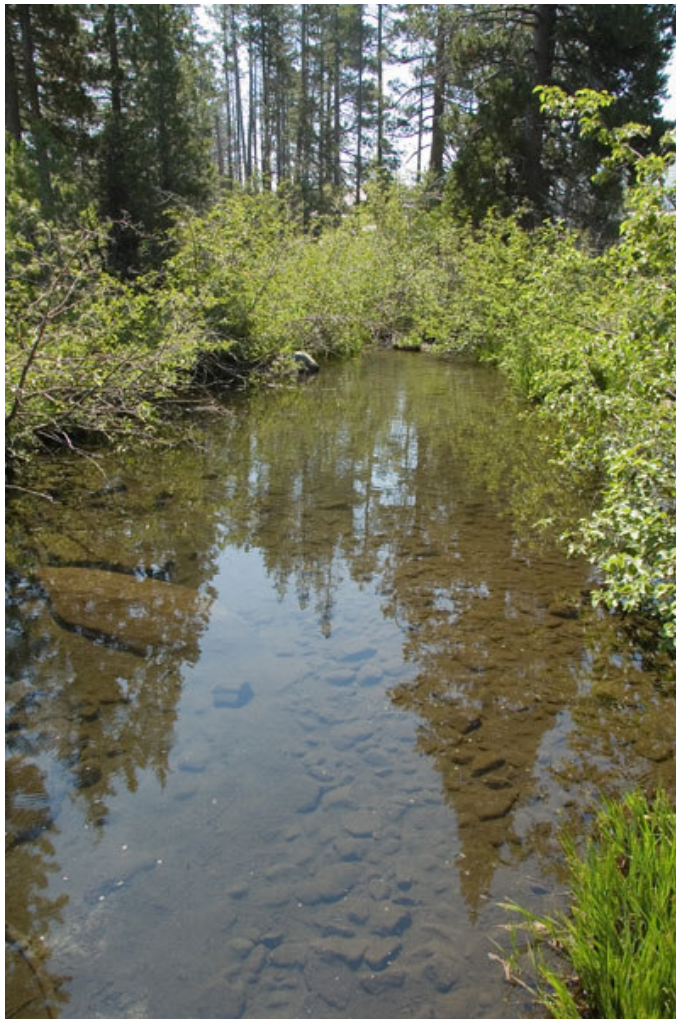
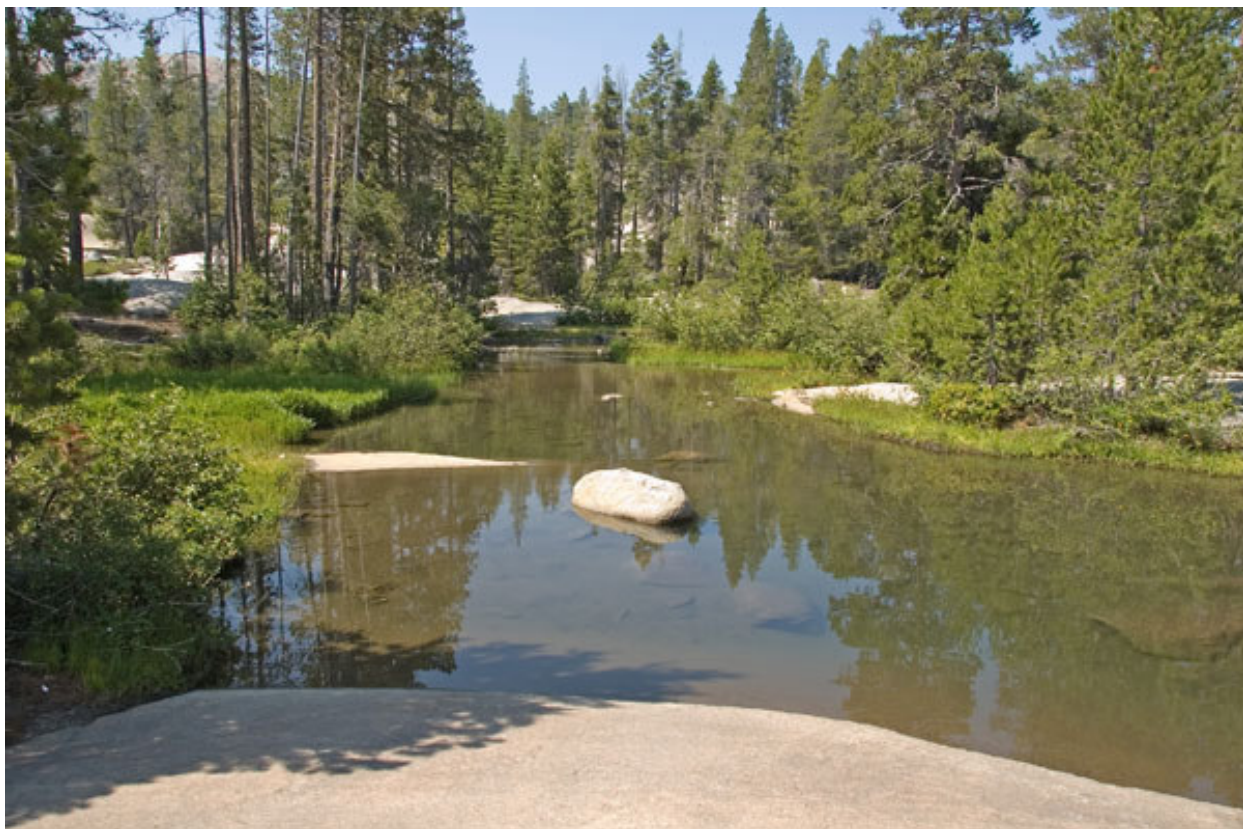
These are photos of the Little Rubicon just downstream from the crossing of the Rubicon Trail. These photos clearly show increased silt and sediments impacting the stream compared to conditions above the vehicle crossings.

Conditions are tragic in this area. These are important water resources that are being allowed to be impacted. The solutions here are pretty straight forward if vehicle use is to be allowed to continue on the Rubicon Trail. All vehicle contact with the Little Rubicon needs to end with the placement of a suitable bridge over the river. This riparian area along the Little Rubicon needs to be permanently closed to all camping and followed up with necessary restoration. It is obvious that the number of users has already greatly exceeded the carrying capacity of the alpine environment along the Rubicon Trail; strict quotas are needed to reduce use. All human waste needs to be carried out by individual users with no more deposition out on the ground. The shift away from the historic use of slightly modified street legal and licensed vehicles over to extremely modified rock crawlers has greatly altered the character of the trail accelerating erosion and increasing the difficulty of travel resulting in more vehicle damage. This has led to increase oil spills. Restoration of the Trail to past historic conditions is long overdue to both address resource issues but also to limit vehicle damage. The solution also necessitates the elimination of green stickered OHVs, the extreme vehicles. If these and other necessary changes cannot be made, the Rubicon Trail needs to be closed to all motorized use.

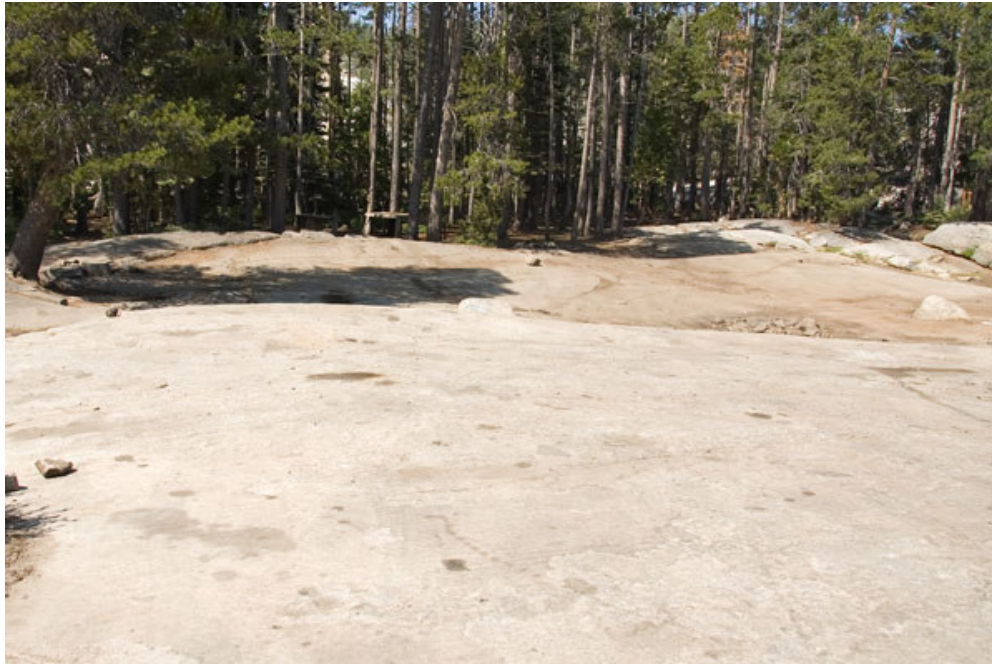
This is just a part of the large camping area impacting the riparian area along the Little Rubicon. This photo shows numerous oil spills as vehicles sit and leak overnight or as repairs are made. Below is a photo of an abandoned oil container and a funnel left in a fire ring.

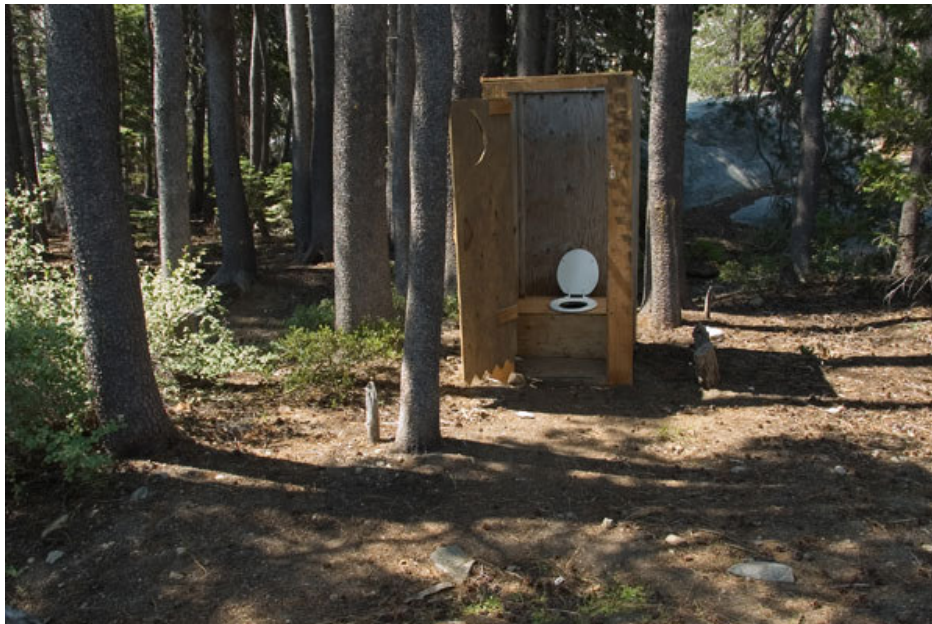
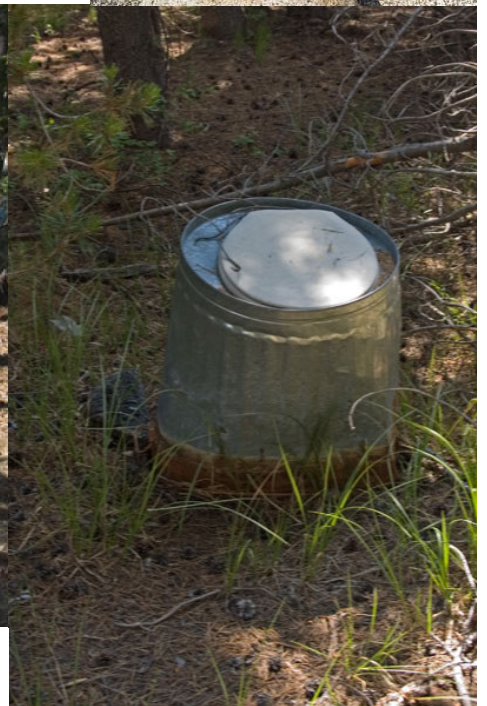
Human waste is of huge concern and an major issue along the entire run of the Rubicon Trail. This riparian area along the Little Rubicon River shows similar conditions that led to the public health closing of the Spider Lake area in the summer of 2004. This area has several user created outhouses. They range from kind of a standard style pictured on the left to the much more simplified version on the right consisting of just an overturned metal garbage can with a toilet seat mounted on it for all the comforts of home. This garbage can is within just a few feet of the water.

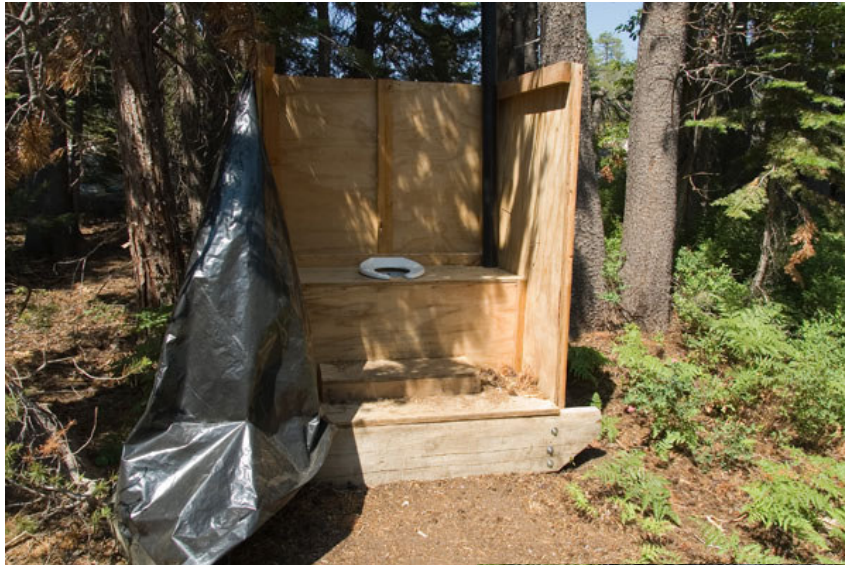
This a more elaborate "palace" built by the 4x4 users and moved from place to place in the surrounding area. In the Spider Lake area mounds of human waste were found in 2005 left behind as outhouses were moved after filling up in one spot. I took this photo with my back to a piece of slow water, a remnant of the water course during higher flows.

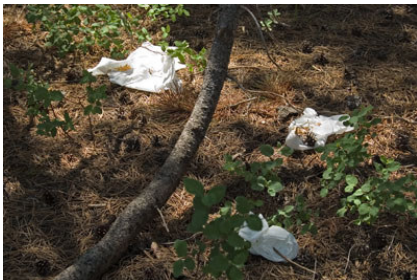
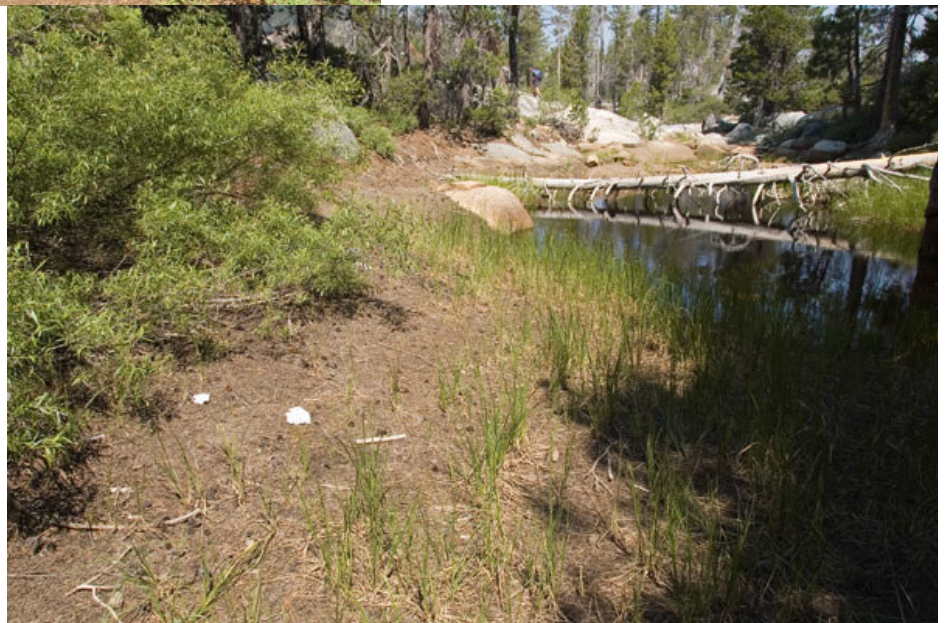
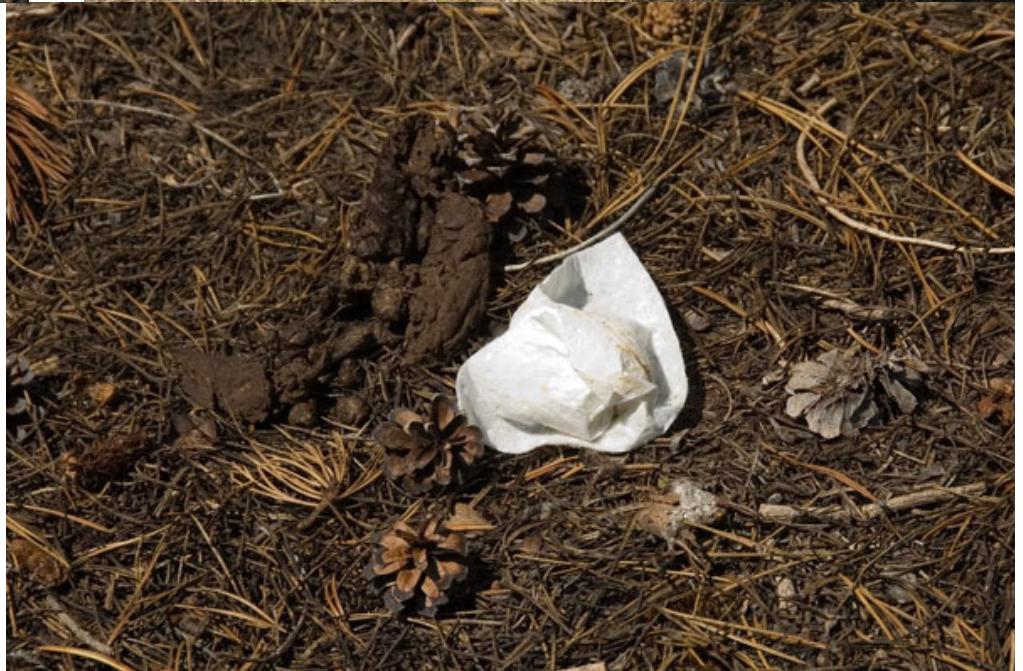
Right around the corner from this outhouse it was a shock to find numerous piles of toilet paper along with human feces lying on the ground
